Laterals / Service Connections

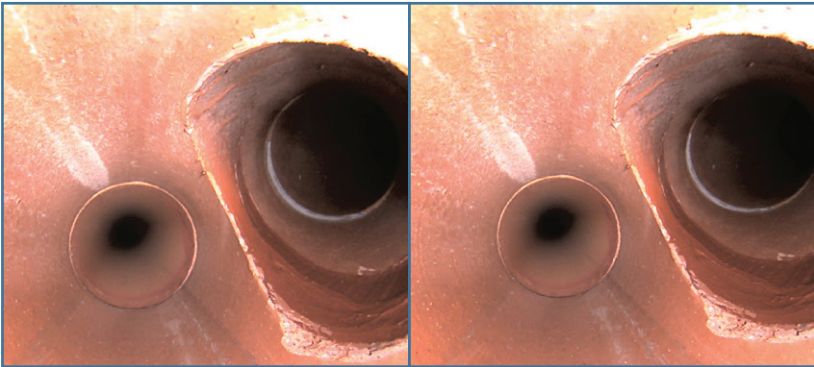
The camera in the mainline provides a partial view of the joint connection at the Y-branch spur and the curve for a service connection. Two images were captured using an 8x6-inch wye branch and a 30° curve. The first image shows a tight and square joint connection and the second has a ¾-inch gap. While the measured gaps are significantly different, they appear the same in the CCTV image from the mainline. Because of this visual similarity, an assessment cannot be made for the lateral connection via CCTV inspection from within the sewer mainline.

Figure 36: Wye Branch connection at 30° curve: Zero angular deflection and no gap *Figure 37: Wye Branch connection at 30° curve: Maximum angular deflection and ¾-inch gap*
