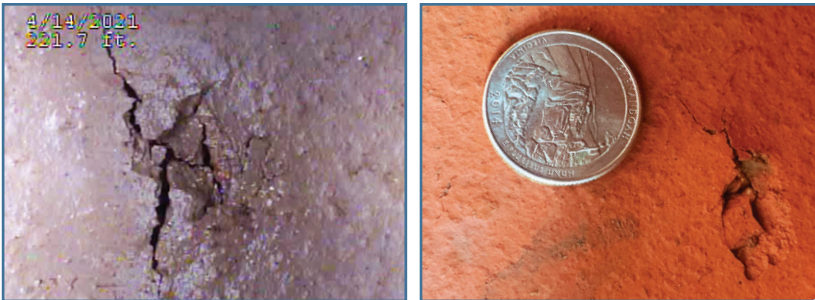
Figure 2: The picture at left was the observed condition of an 8-inch pipe in a CCTV inspection. The photo at right is the recovered pipe that passed the air test. The cosmetic imperfection is well-within the chip allowance specified in ASTM C700 and would have had no impact on long-term performance. For more examples of cosmetic imperfections, see pages 18 & 19.
