Pulled Joints (GAPS – Installation Anomaly)

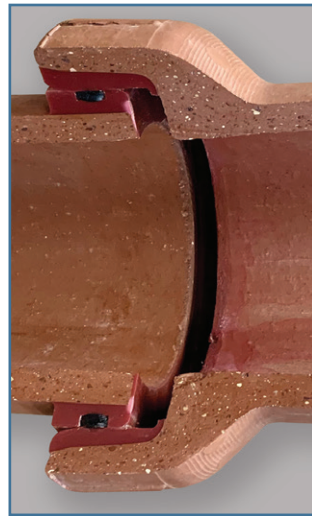
During construction, joints must be assembled to assure pipeline integrity. When using a trench box, pipe must be held in place when the box is moved forward to ensure the assembled joint does not pull apart. If joints have been pulled, a larger gap may result between the pipe ends. The joint design for clay pipe provides an allowance for joint gap without sacrificing pipeline integrity, see Figures 19 & 20.

Figure 20: While this joint cutaway shows a significant gap in the pulled joint for illustration purposes, the joint holds and would perform as specified.

Whenever there is doubt about the integrity of the joint seal, the Low-Pressure Air Test is recommended. If the installation passes the Low-Pressure Air Test, pipeline performance and pipe integrity should be unaffected.

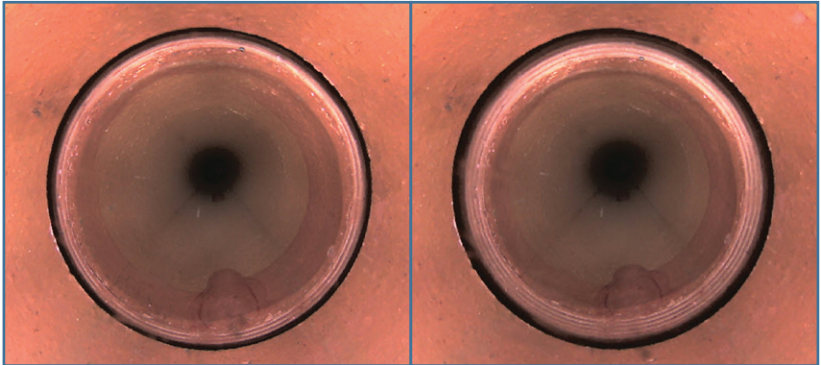
The images below show a $\frac{3}{8}$ -inch and a 1-inch joint gap as viewed with the CCTV camera. Both joints passed a Low-Pressure Air Test to verify joint integrity.

Figure 21: $\frac{3}{8}$ -inch Pulled Joint (gap)

Figure 22: 1-inch Pulled Joint (gap)
