Analyzing CCTV Inspection of Vitrified Clay Pipe

NATIONAL CLAY PIPE INSTITUTE

The goal of this handbook is to serve the needs of CCTV camera operators and their utilities by providing clarity around common issues when using CCTV to inspect Vitrified Clay Pipe (VCP) lines. Each specific condition is highlighted on a separate page with an illustration of the condition and a CCTV image from inside the pipeline.

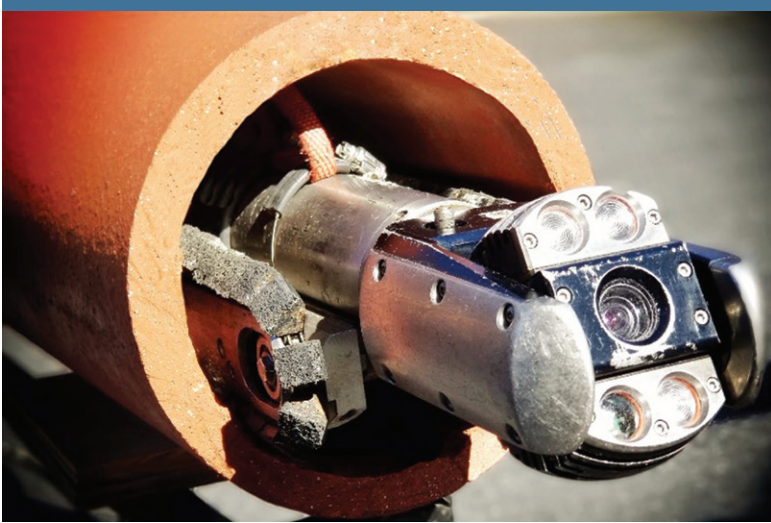
Figure 1: A CCTV camera in an 8" pipe.

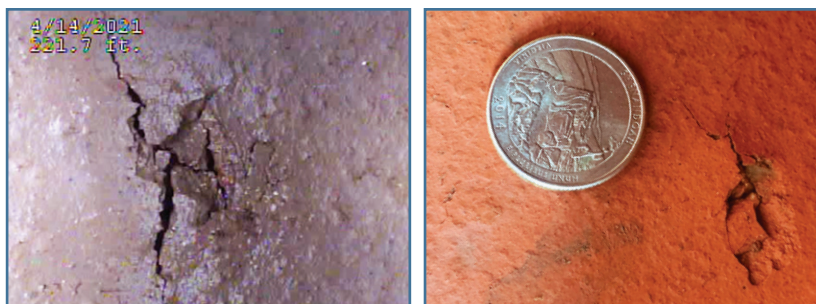
Figure 2: The picture at left was the observed condition of an 8-inch pipe in a CCTV inspection. The photo at right is the recovered pipe that passed the air test. The cosmetic imperfection is well-within the chip allowance specified in ASTM C700 and would have had no impact on long-term performance. For more examples of cosmetic imperfections, see pages 18 & 19.

Of the various pipe materials found in sanitary sewers throughout the U.S., VCP will frequently be the oldest sewer pipe in a collection system. As a kiln-fired ceramic, VCP is a natural material with some dimensional and cosmetic variations being normal, such as the “lime pop” in the pictures on page 2. A small piece of lime may occasionally be close to the pipe surface after extrusion. During firing, this lime may “pop” and result in the marks seen in Figure 2 on page 2. These should not be regarded as a cause for rejection.

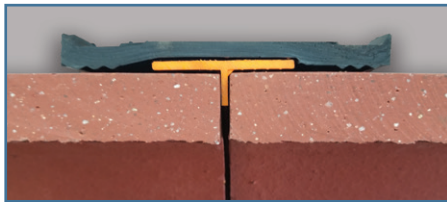
Figure 5: Plain-end pipe with rubber compression couplings, internal shear ring, and stainless steel tightening bands.

As is apparent in the joint designs pictured in Figures 3, 4, 5 and 6 it is impossible to “over-home” a VCP joint.

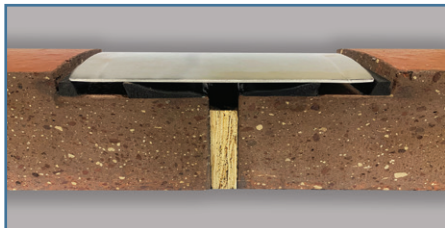
Figure 6: VCP jacking pipe joint.

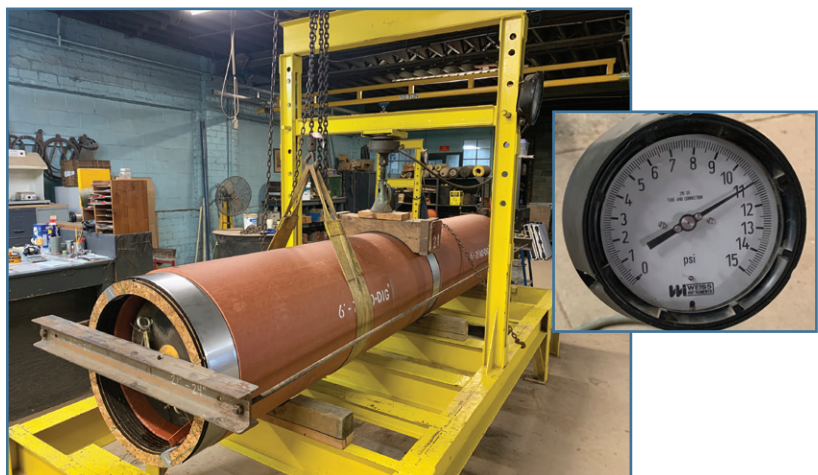
Figure 8: 21-inch VCP Jacking pipe passing the same test.

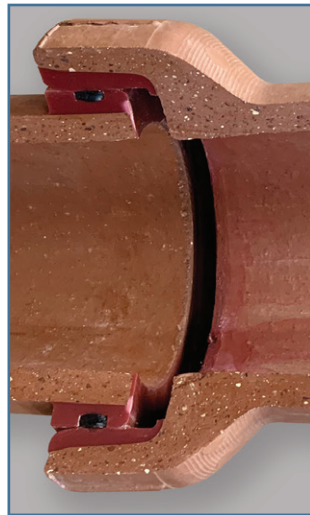
Figure 20: While this joint cutaway shows a significant gap in the pulled joint for illustration purposes, the joint holds and would perform as specified.

During construction, joints must be assembled to assure pipeline integrity. When using a trench box, pipe must be held in place when the box is moved forward to ensure the assembled joint does not pull apart. If joints have been pulled, a larger gap may result between the pipe ends. The joint design for clay pipe provides an allowance for joint gap without sacrificing pipeline integrity, see Figures 19 & 20.

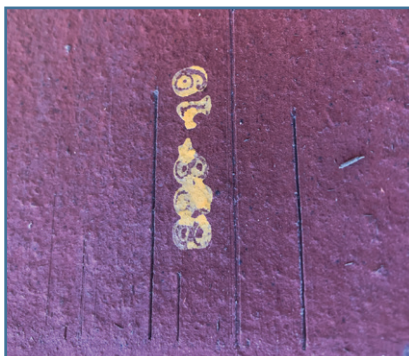
Figure 27: Cosmetic Imperfection (caused by extrusion marks)

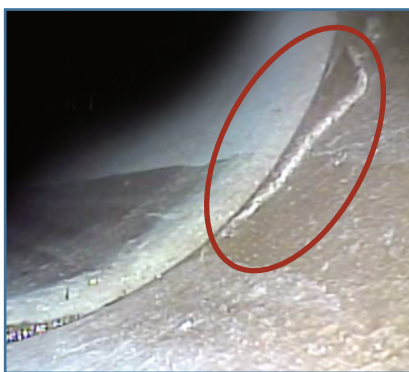
Figure 28 shows a piece of excess clay that fell from the pipe end trimmer/ finisher and was stuck/ pressed to the inside of the 6-inch pipe wall. This happened after the pipe was extruded and before it was kiln fired. After firing it was permanently bonded.

The thickness is less than $\frac{1}{16}$ -inch but the lighting and the camera really exaggerates the blemish as it wasn't noticeable with the naked eye.

Figure 28: Surface imperfection created during extrusion

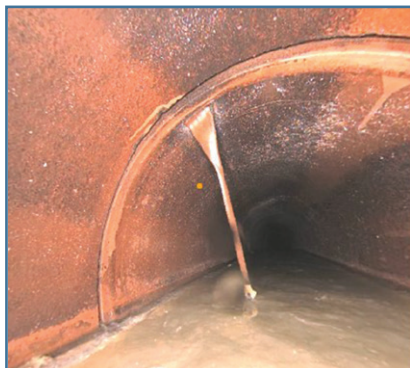
Figure 29 shows polyurethane material that ran down inside the pipe when the bell gasket was poured during manufacturing. Each pipe section stands on end vertically while the bell gaskets are poured within a mold inside the pipe bell. This material spill was missed and didn't get cleaned off before the pipe was shipped, installed and inspected.

Figure 29: CCTV image of polyurethane gasket overpour

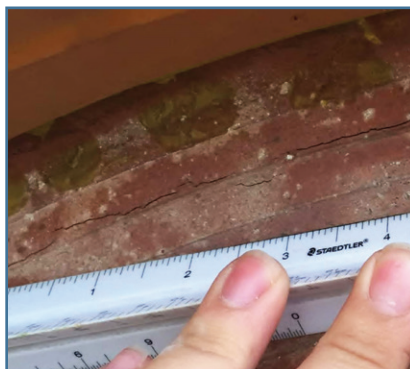
Crazing is a surface blemish that can occur anywhere on the pipe surface. It can be highly exaggerated by the CCTV light source and camera magnification during inspection.

All of these conditions are cosmetic imperfections and will not affect the performance or integrity of the pipeline or joint system. Fractures as compared to cosmetic imperfections, go all the way through the pipe wall. They will almost always start at one end of a pipe section.

Figure 30: Crazing (pictured here) is common, but it has also been misidentified as a fracture or crack.

Crazing (also referred to as surface shrinkage, surface checking, firing checks or drying checks) is a common manufacturing condition on the surface of the pipe. This can occur on the inside surface of the barrel during the trim/chamfer process or on the outside of the barrel where the bell meets the body of the pipe. It does not affect the performance of the pipe in any way.

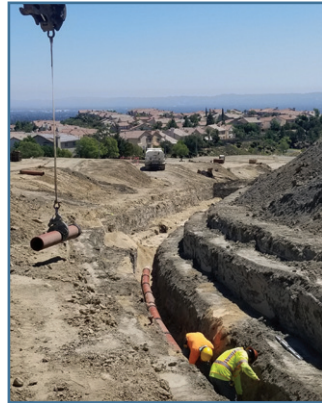
Figure 32: Installation of a curvilinear sewer
