Cosmetic Imperfections

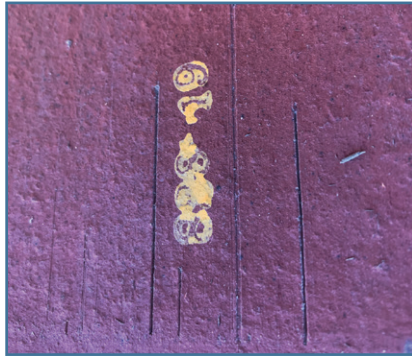
Be very careful in identifying breaks, fractures or cracks. Marks on the inside of the pipe may only be cosmetic imperfections on the inside surface. These marks are commonly caused by handling with a forklift, residual water lines from cleaning, or sewage flow marks. These have, on occasion, been mistaken for cracks or fractures.

Figure 27: Cosmetic Imperfection (caused by extrusion marks)

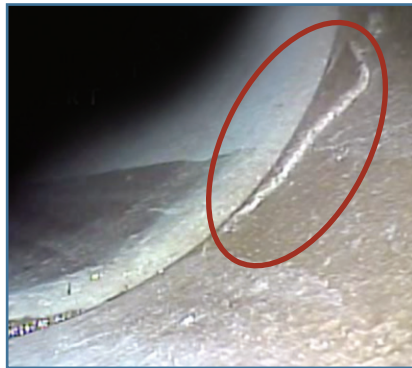
Figure 28 shows a piece of excess clay that fell from the pipe end trimmer/ finisher and was stuck/ pressed to the inside of the 6-inch pipe wall. This happened after the pipe was extruded and before it was kiln fired. After firing it was permanently bonded.

The thickness is less than $\frac{1}{16}$ -inch but the lighting and the camera really exaggerates the blemish as it wasn't noticeable with the naked eye.

Figure 28: Surface imperfection created during extrusion

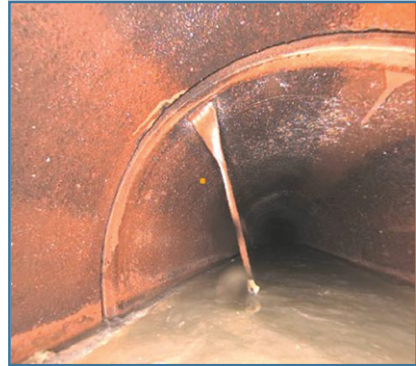
Figure 29 shows polyurethane material that ran down inside the pipe when the bell gasket was poured during manufacturing. Each pipe section stands on end vertically while the bell gaskets are poured within a mold inside the pipe bell. This material spill was missed and didn't get cleaned off before the pipe was shipped, installed and inspected.

Figure 29: CCTV image of polyurethane gasket overpour

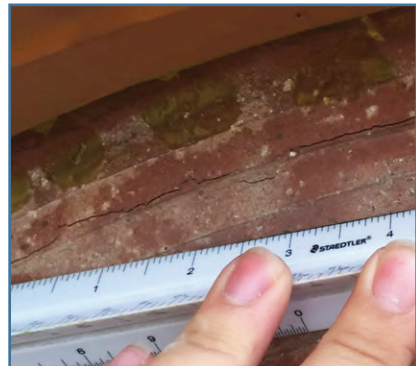
Crazing (also referred to as surface shrinkage, surface checking, firing checks or drying checks) is a common manufacturing condition on the surface of the pipe. This can occur on the inside surface of the barrel during the trim/chamfer process or on the outside of the barrel where the bell meets the body of the pipe. It does not affect the performance of the pipe in any way.

Crazing is a surface blemish that can occur anywhere on the pipe surface. It can be highly exaggerated by the CCTV light source and camera magnification during inspection.

Figure 30: Crazing (pictured here) is common, but it has also been misidentified as a fracture or crack.

All of these conditions are cosmetic imperfections and will not affect the performance or integrity of the pipeline or joint system. Fractures as compared to cosmetic imperfections, go all the way through the pipe wall. They will almost always start at one end of a pipe section.
